ELEMENTS PROPERTY REPORT

5915 Highland Hills Circle Fort Collins, CO, 80528, US

Vexcel Group

Report date: 05 February 2024

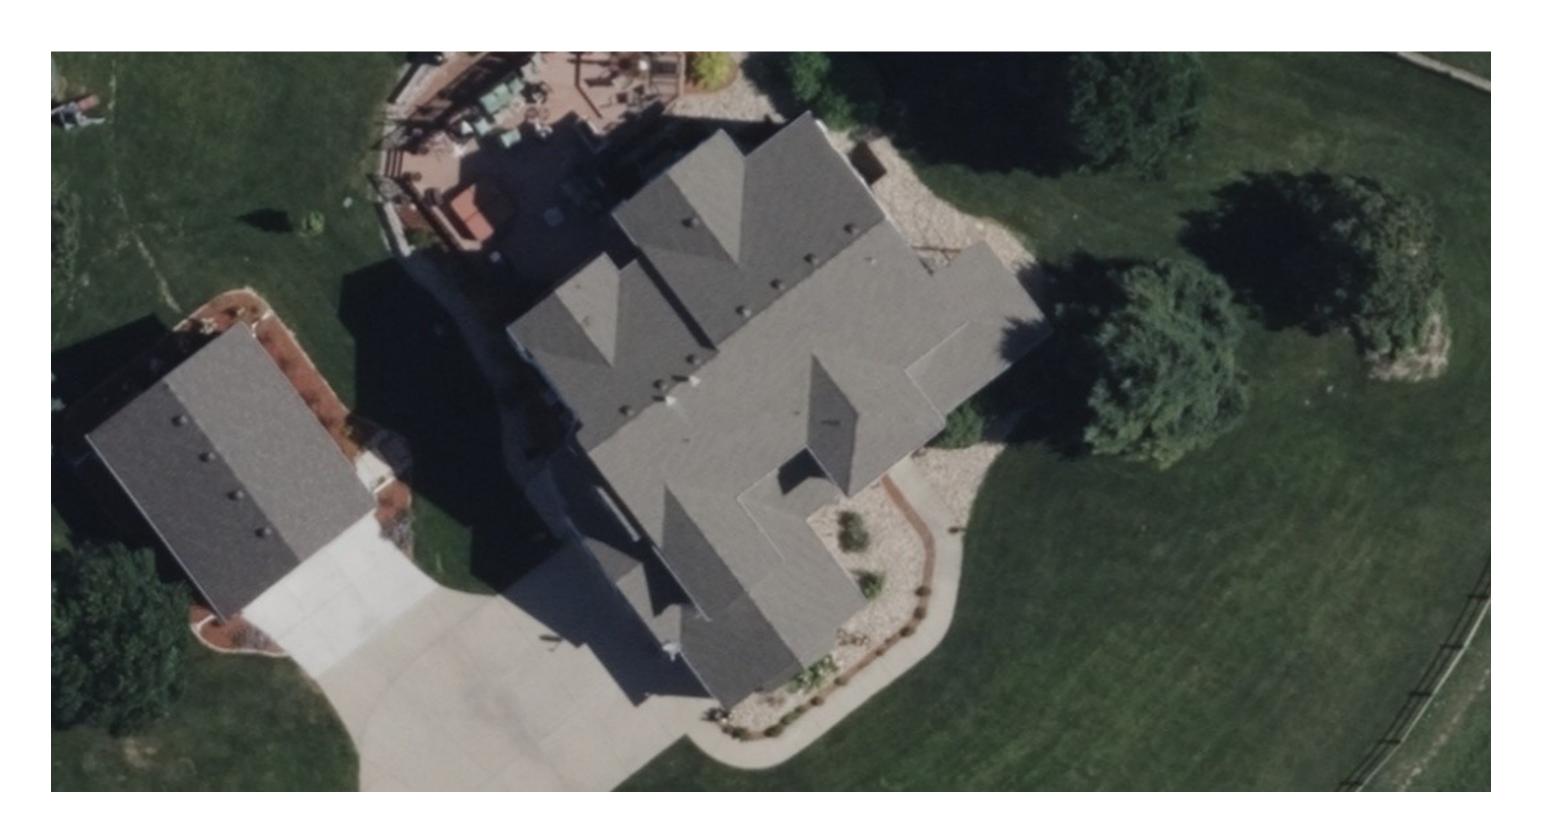
Primary Building: Attributes

Ground elevation	1506.32 m	Chimney(s)	0
Footprint area	317.35 m ²	AC unit(s)	0
Roof elevation	1512.2 m	Roof vent(s)	14
Roof height	6.75 m	Satellite dish(es)	1
Roof centroid	-104.966454 40.471402	Skylight(s)	0
Tree cover over roof	0		
Roof solar	No

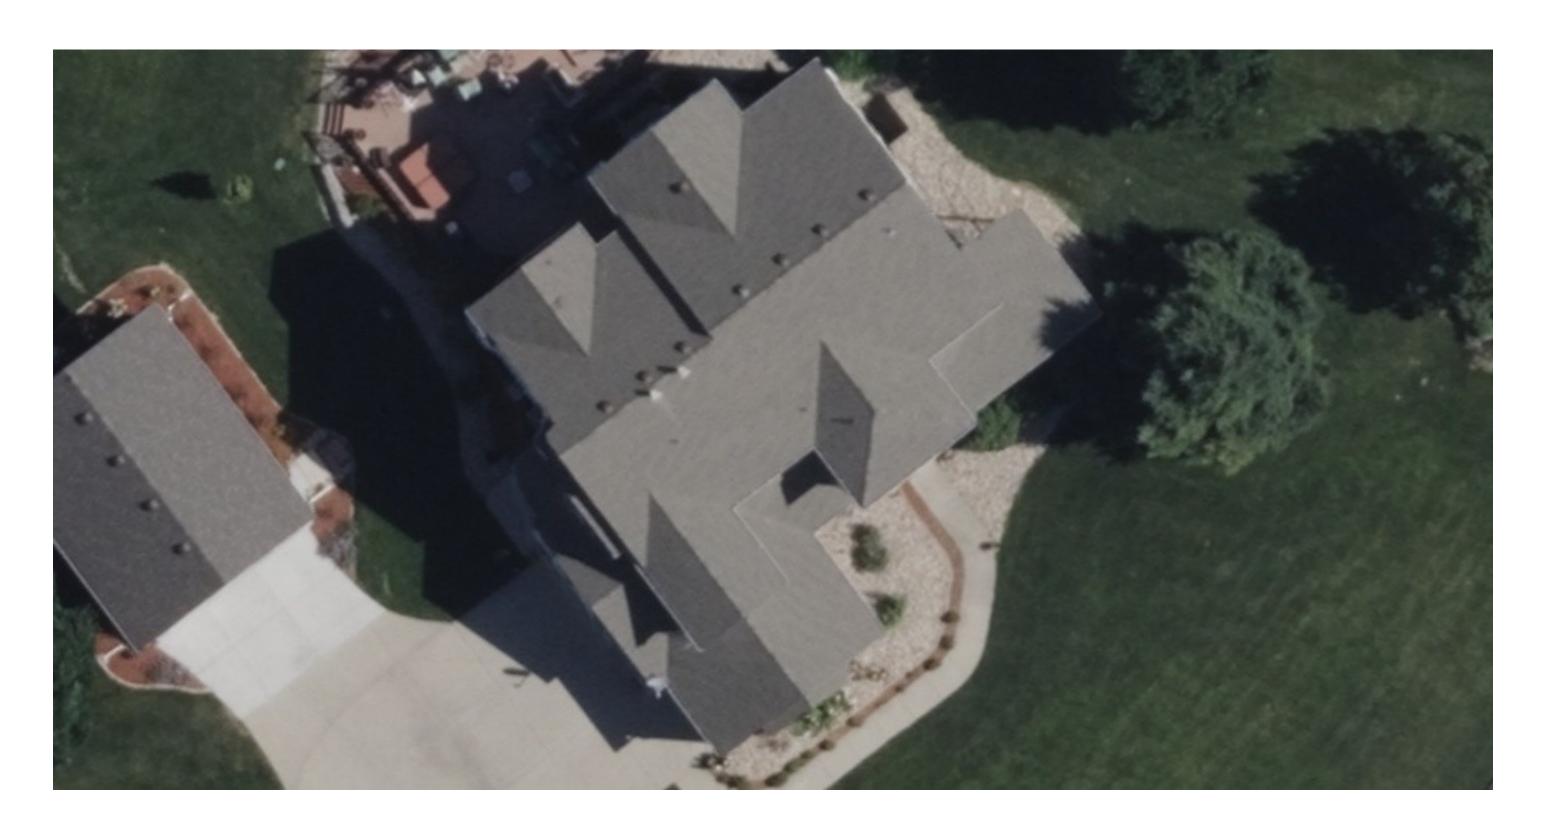
Primary Building: Roof Attributes

Roof shape	gable	Missing roof material	0%
Roof material	shingle	Roof tarp	0%
Roof condition	5/5	Debris	0%
Roof discoloration	0.03%		
Vent staining	0%		
Algae staining	0.03%		
Water pooling	0%

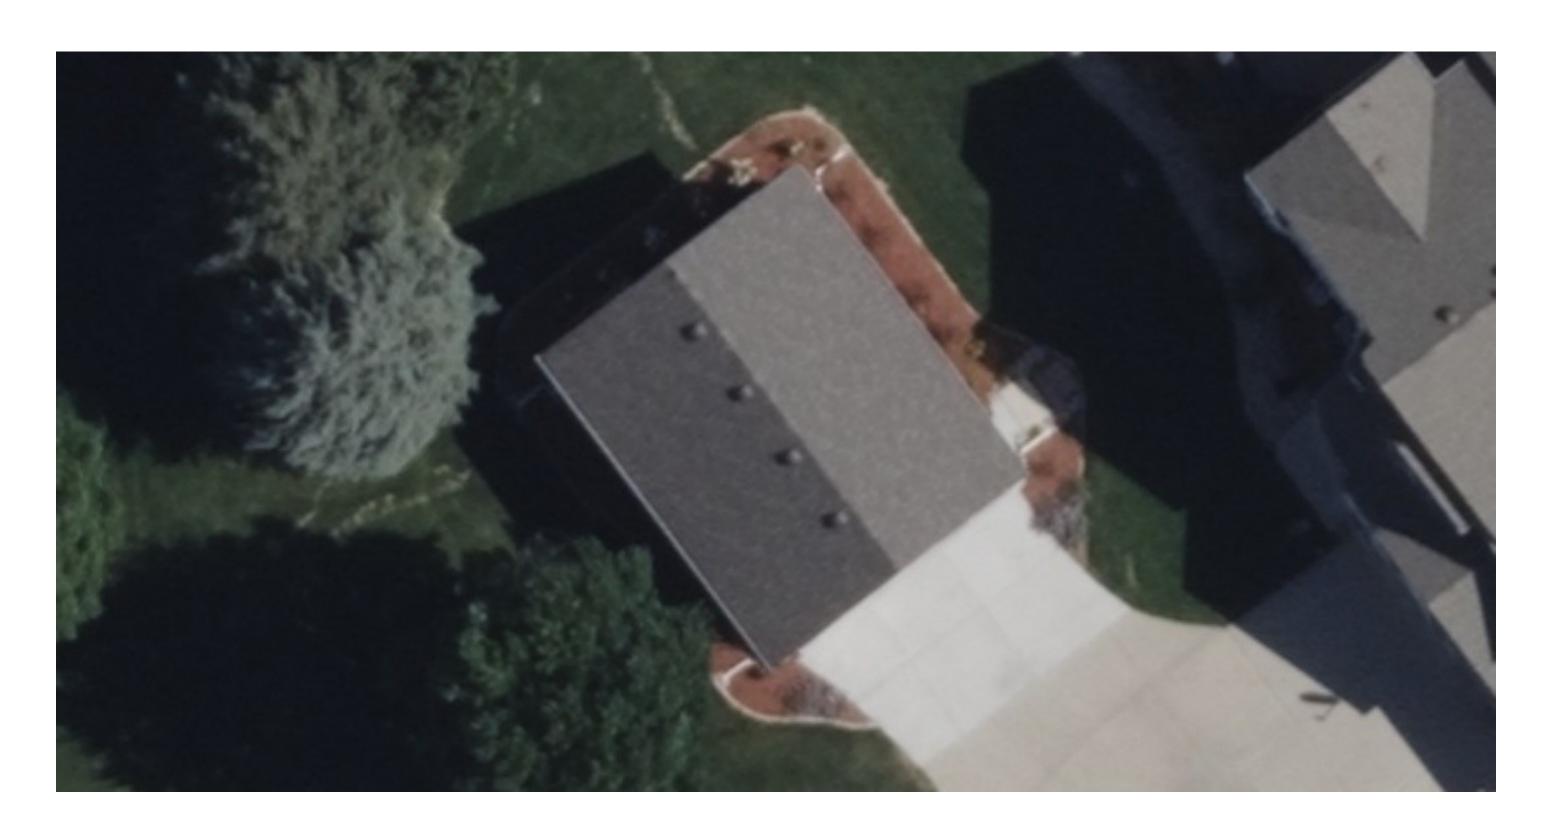
Additional Building: Attributes

Ground elevation	1506.93 m	Chimney(s)	0
Footprint area	82.31 m ²	AC unit(s)	0
Roof elevation	1509.58 m	Roof vent(s)	4
Roof height	3.79 m	Satellite dish(es)	0
Roof centroid	-104.966726 40.471368	Skylight(s)	0
Tree cover over roof	0		
Roof solar	No

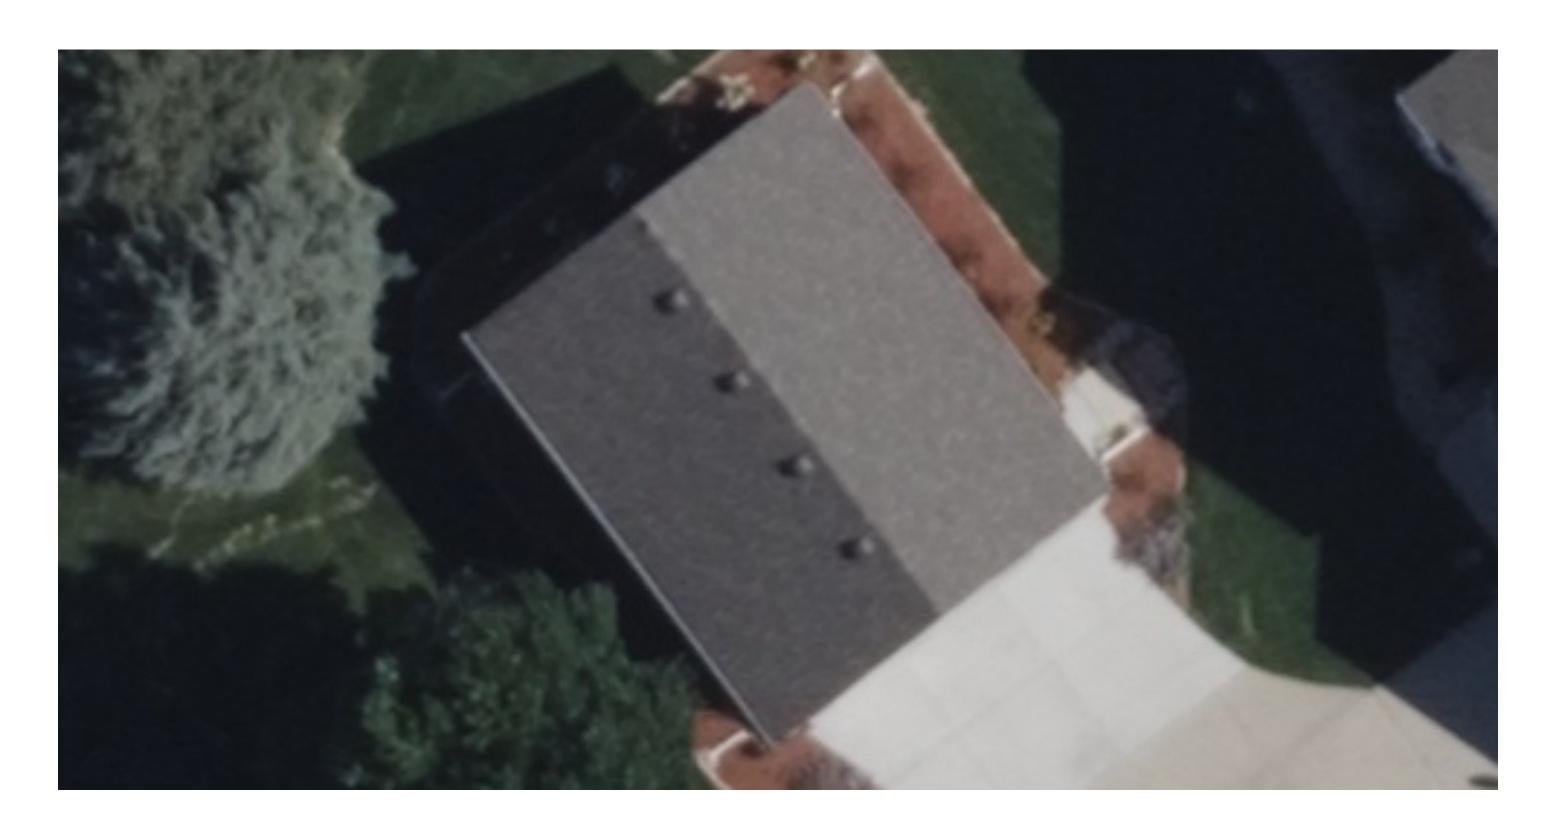
Additional Building: Roof Attributes

Roof shape	gable	Missing roof material	0%
Roof material	shingle	Roof tarp	0%
Roof condition	5/5	Debris	0%
Roof discoloration	0%		
Vent staining	0%		
Algae staining	0%		
Water pooling	0%
