ELEMENTS DAMAGE ASSESSMENT REPORT

1400 South Andover Road
Andover, KS, 67002, US

Report ID: D75560903

Damage Report - Primary Building Assessment

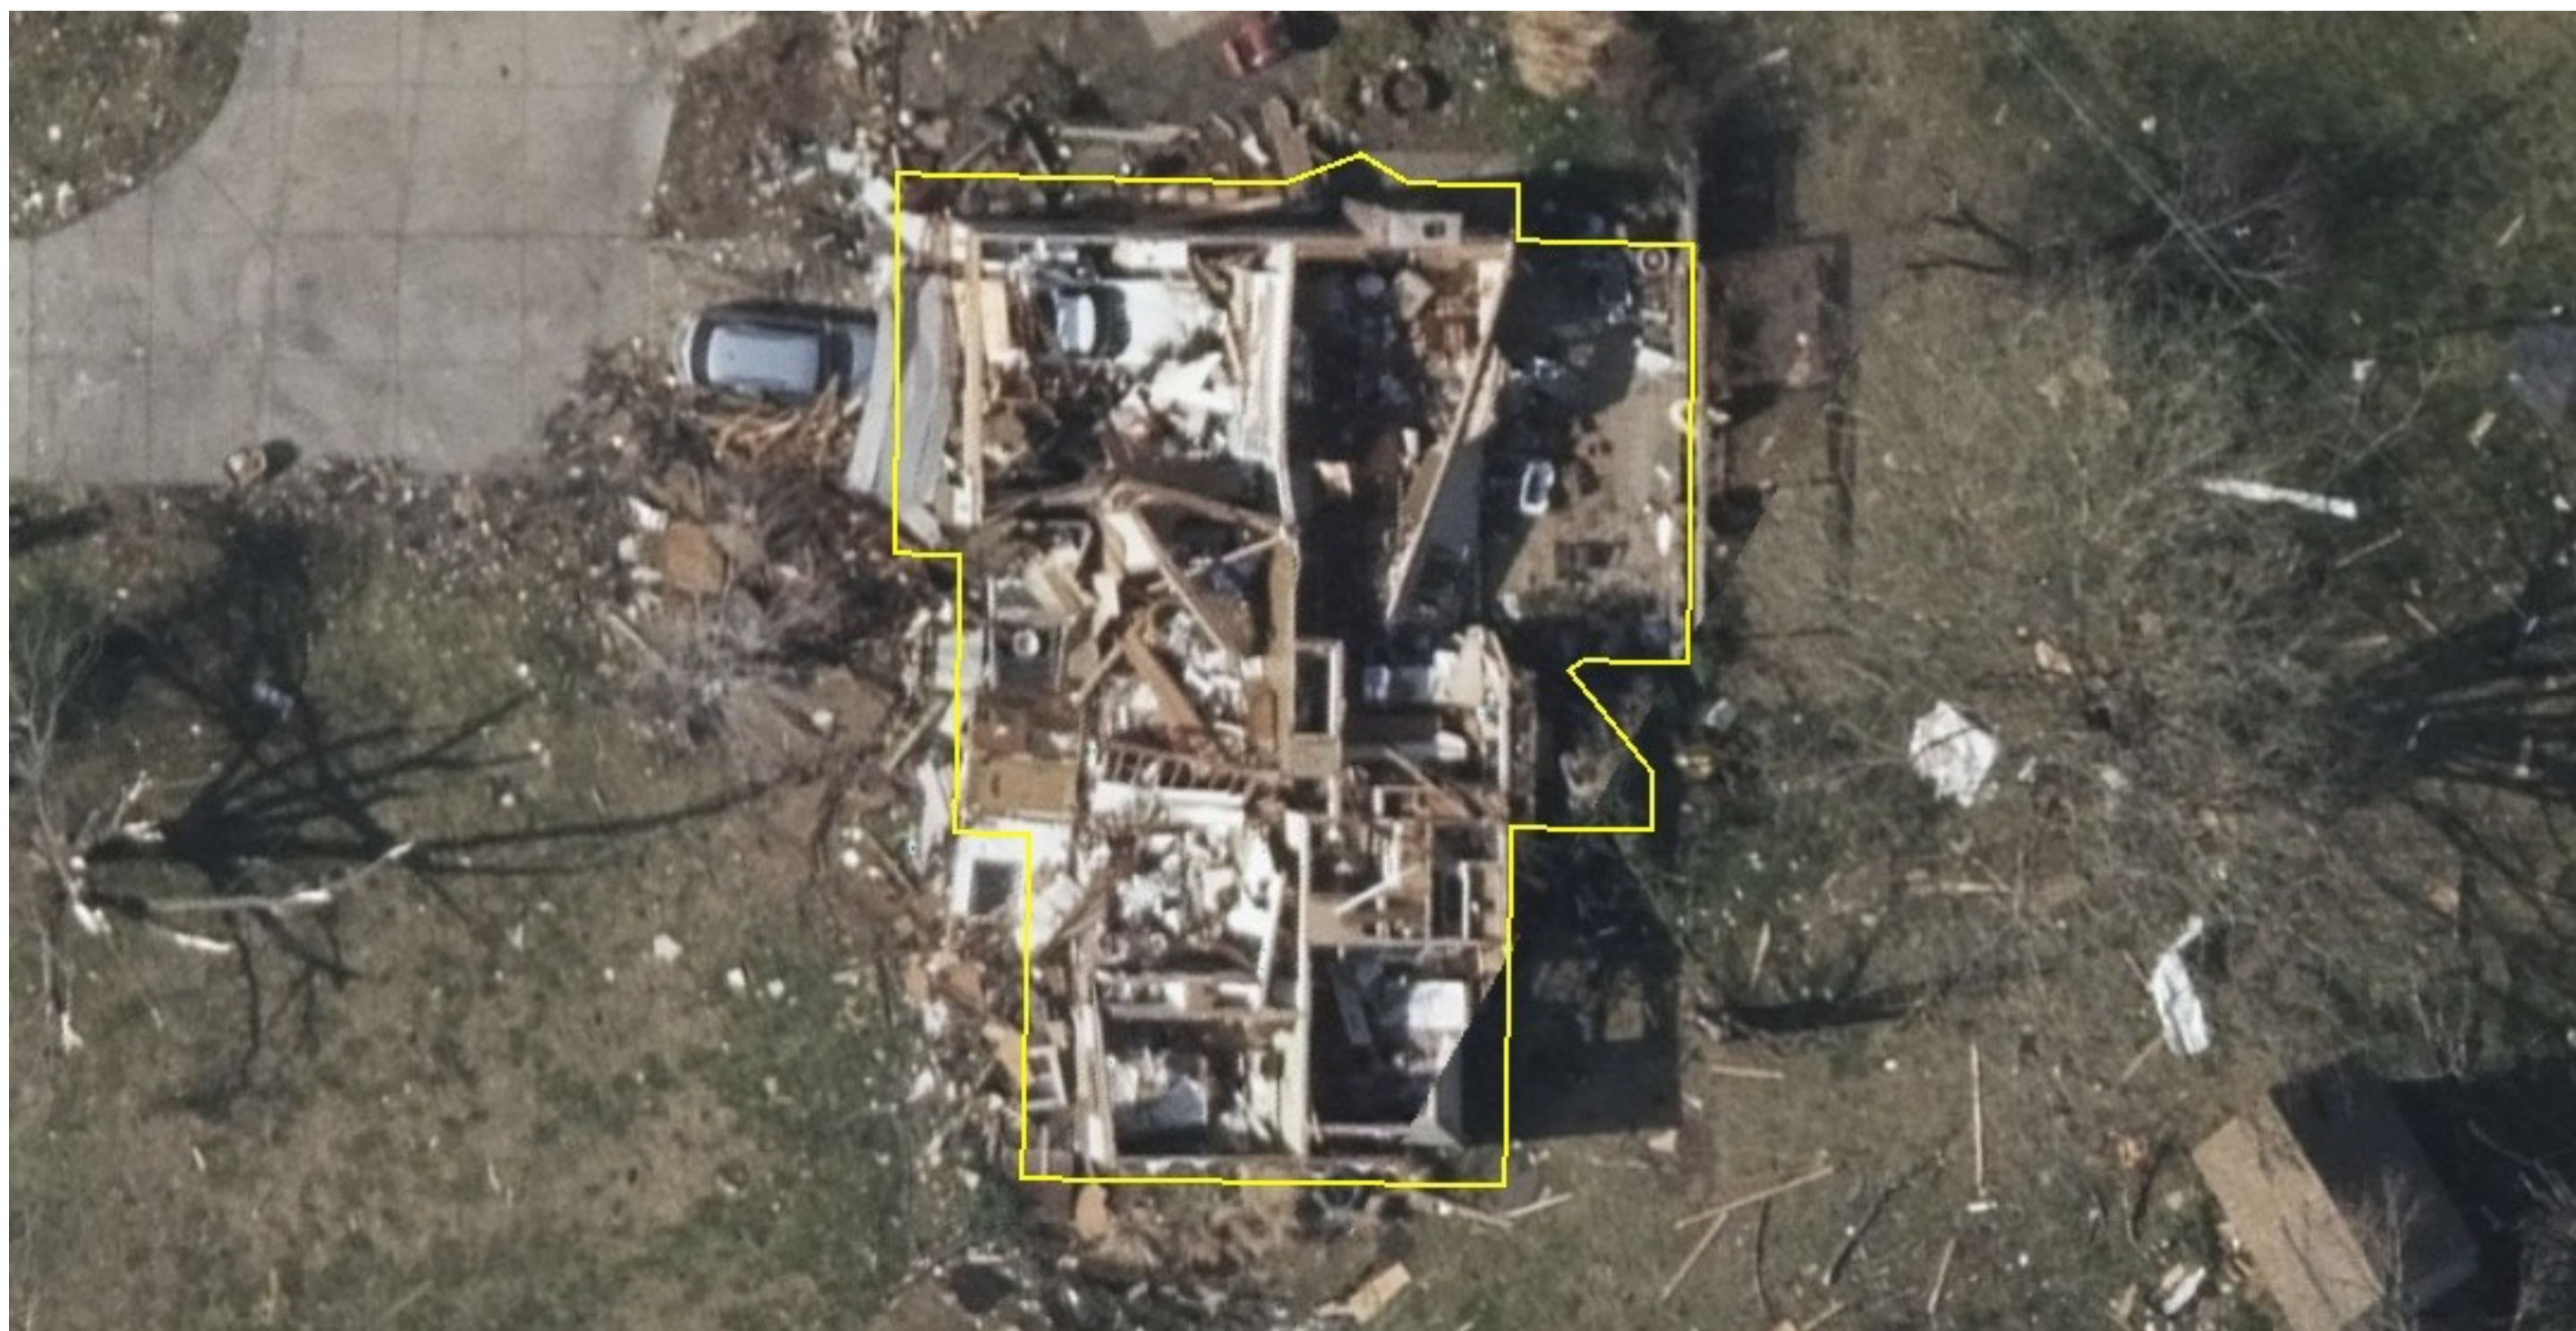
Catastrophe Score	100/100
Approx. FEMA Score	FEMA 6 / Destroyed
Roof Structure damage	0%
Missing Material	0%
Tarp covering roof	0%
Roof debris	0%
Roof discoloration	0%

Catastrophe score: Overall score of total damage to the structure
Approx. FEMA Score: An estimation of damage to the structure meant to align closely with FEMA's classification categories

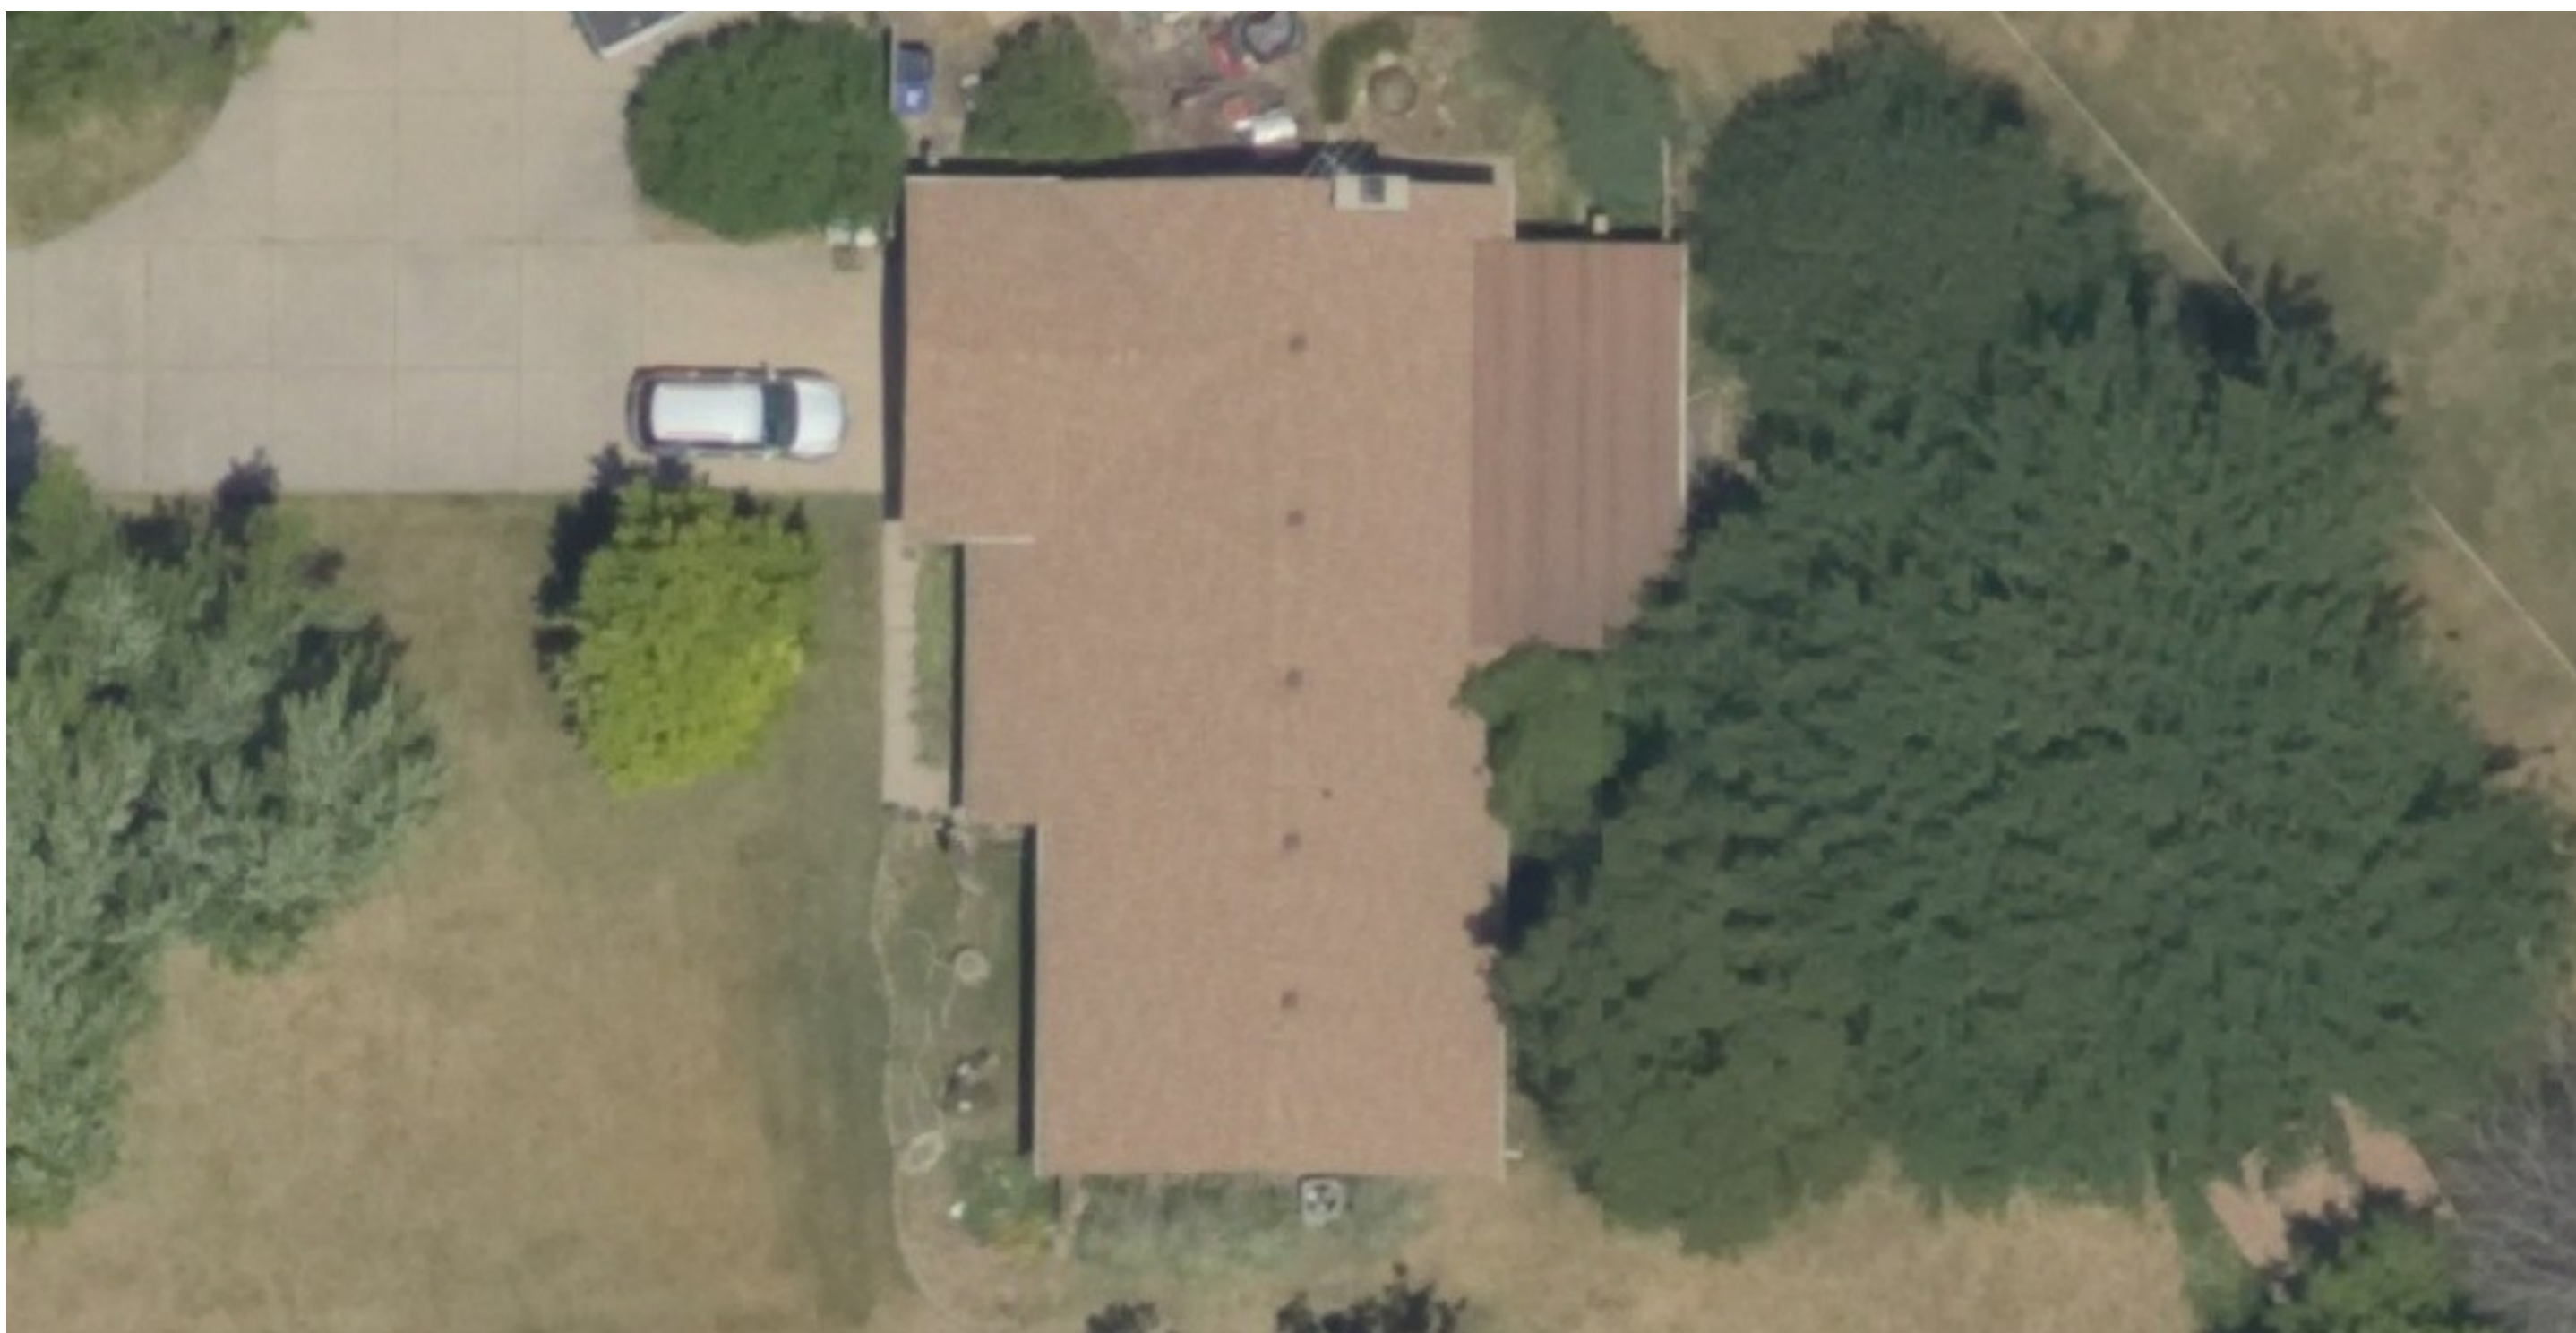
Pre-Damage Primary Building and Roof Attributes

Ground elevation	397.46 m	Roof shape	gable
Footprint area	300.49 m ²	Roof material	shingle
Roof elevation	0 m	Roof condition	5/5
Roof height	0 m	Roof discoloration	0%
Roof centroid	-97.134830 37.667806	Missing roof material	0%
Tree cover over roof	2%	Roof tarp	0%
Roof solar	No

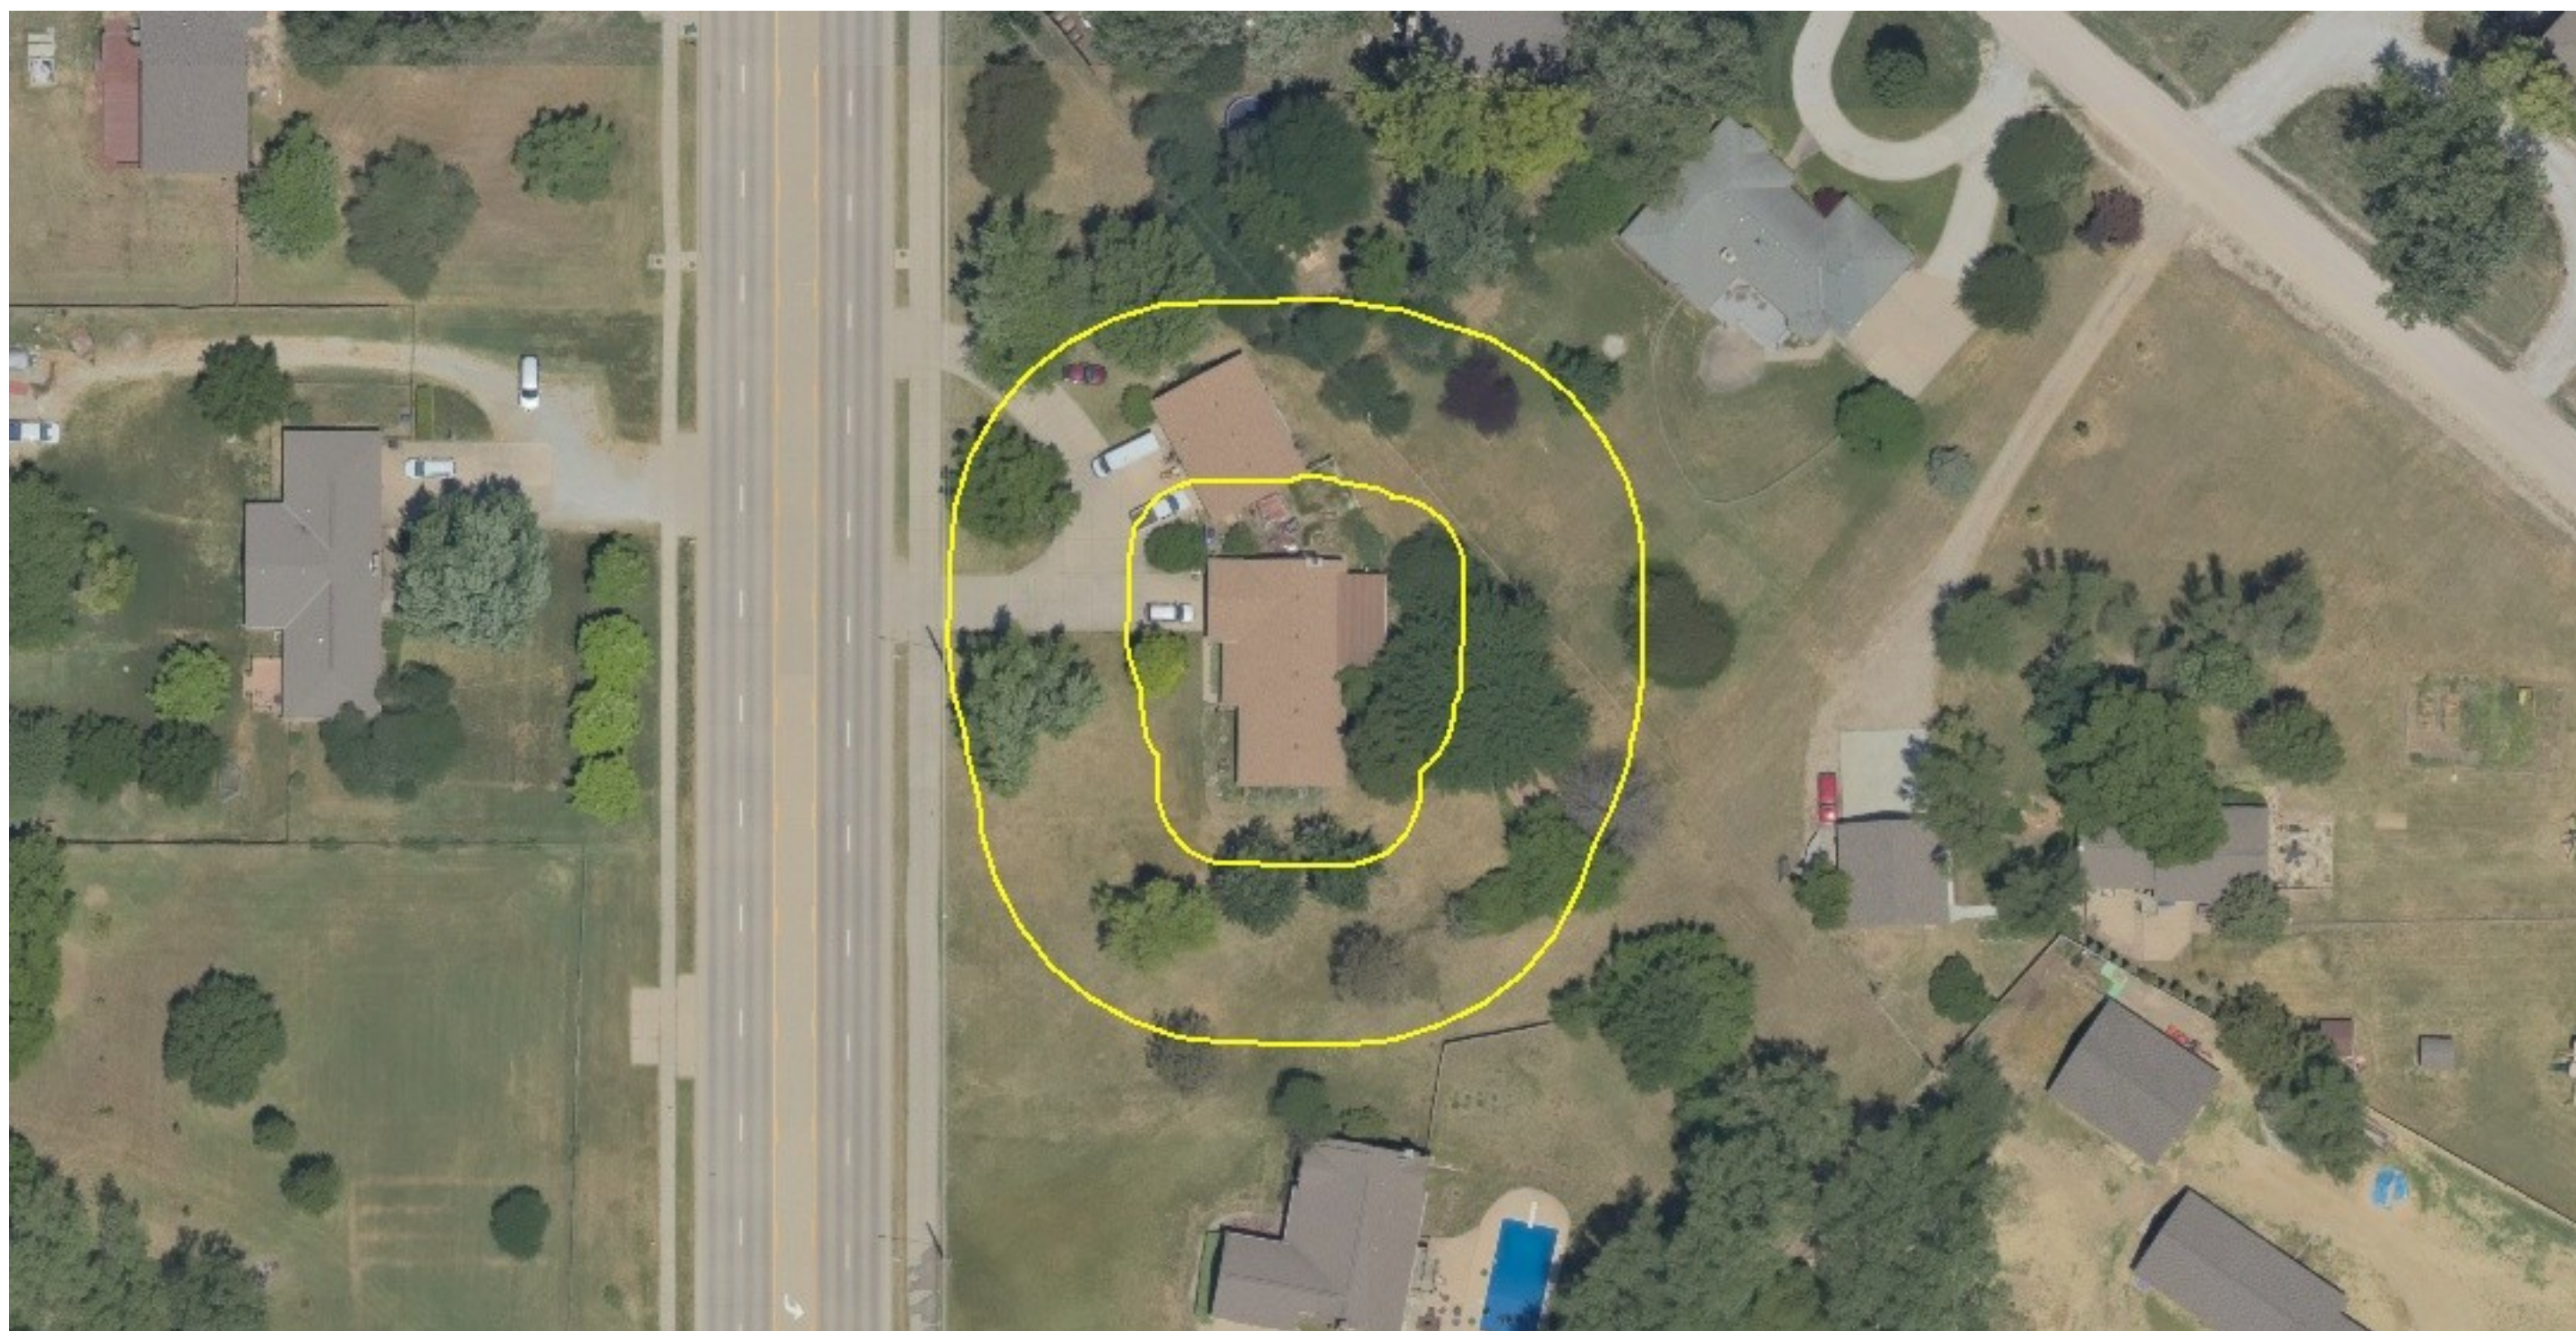
Pre-Damage Primary Building: Defensible Space

DSB 5 ft	N/A	DST 5 ft	N/A
DSB 30 ft	5%	DST 30 ft	42%
DSB 100 ft	3%	DST 100 ft	43%
DSB 200 ft	N/A	DST 200 ft	N/A

DSB - Defensible space building
 DST - Defensible space trees
 Metrics above relate to 5, 30, 100, and 200 foot buffers for both buildings and trees.

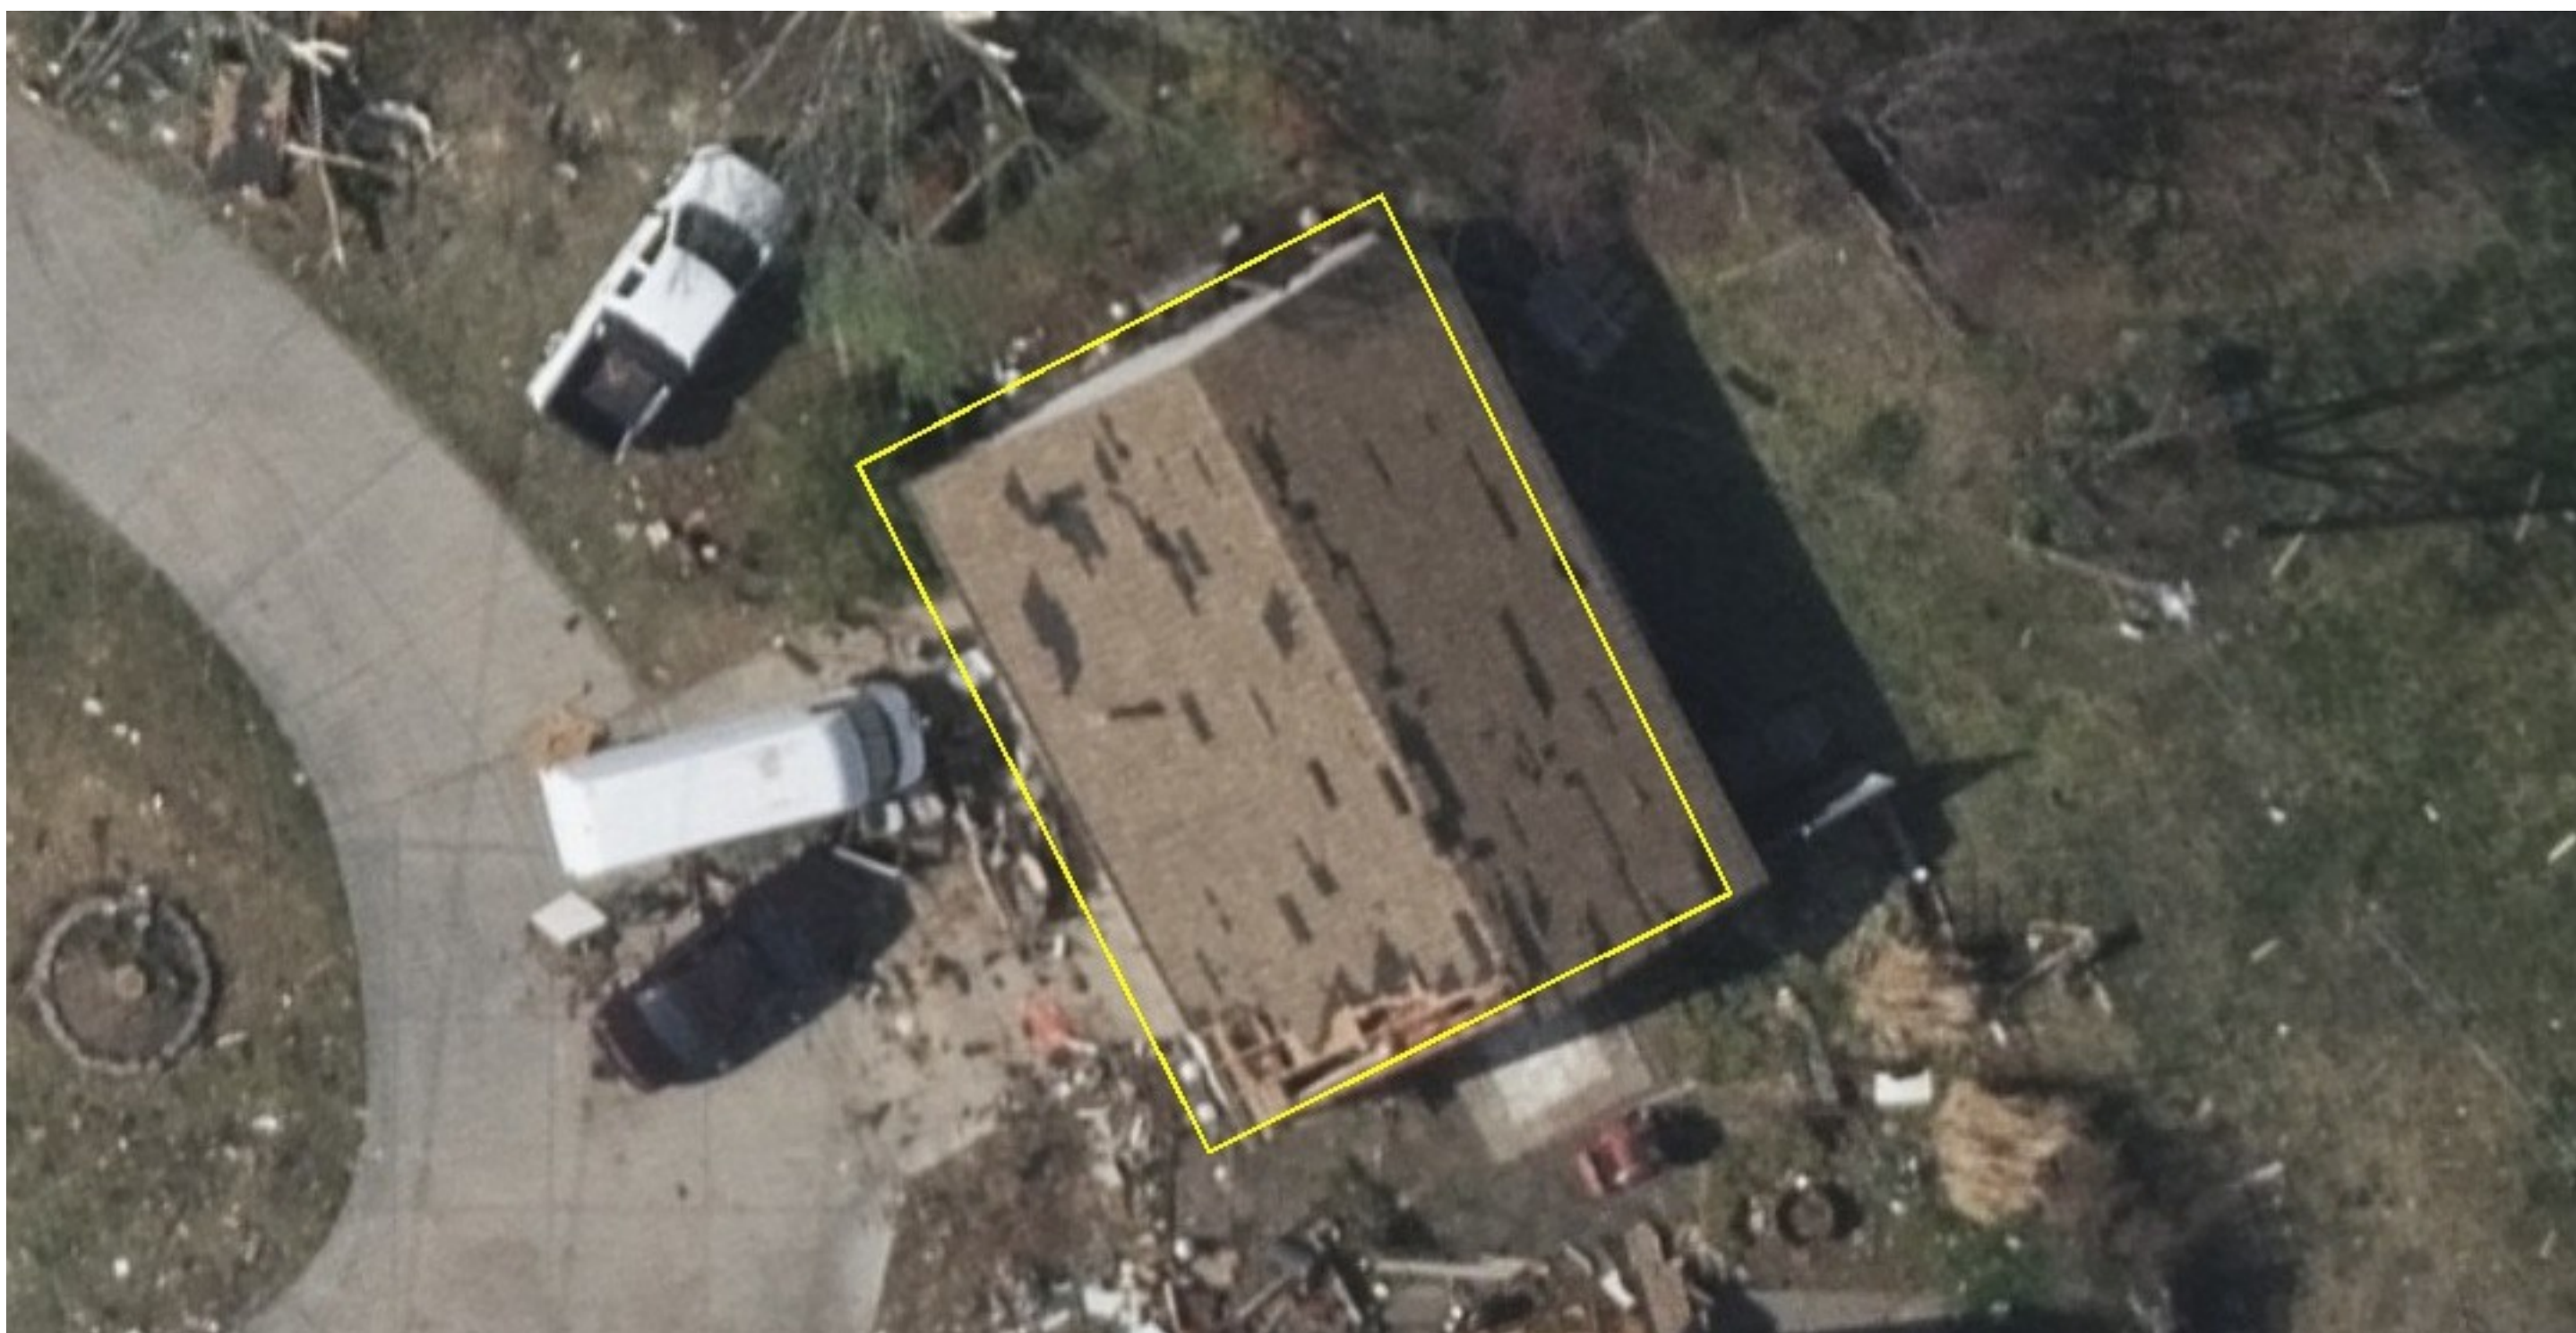
Damage Report - Additional Building Assessment

Catastrophe Score	24.99/100
Approx. FEMA Score	FEMA 4 / Major
Roof Structure damage	3.47%
Missing Material	18.05%
Tarp covering roof	0%
Roof debris	0%
Roof discoloration	0%

Catastrophe score: Overall score of total damage to the structure
Approx. FEMA Score: An estimation of damage to the structure meant to align closely with FEMA's classification categories

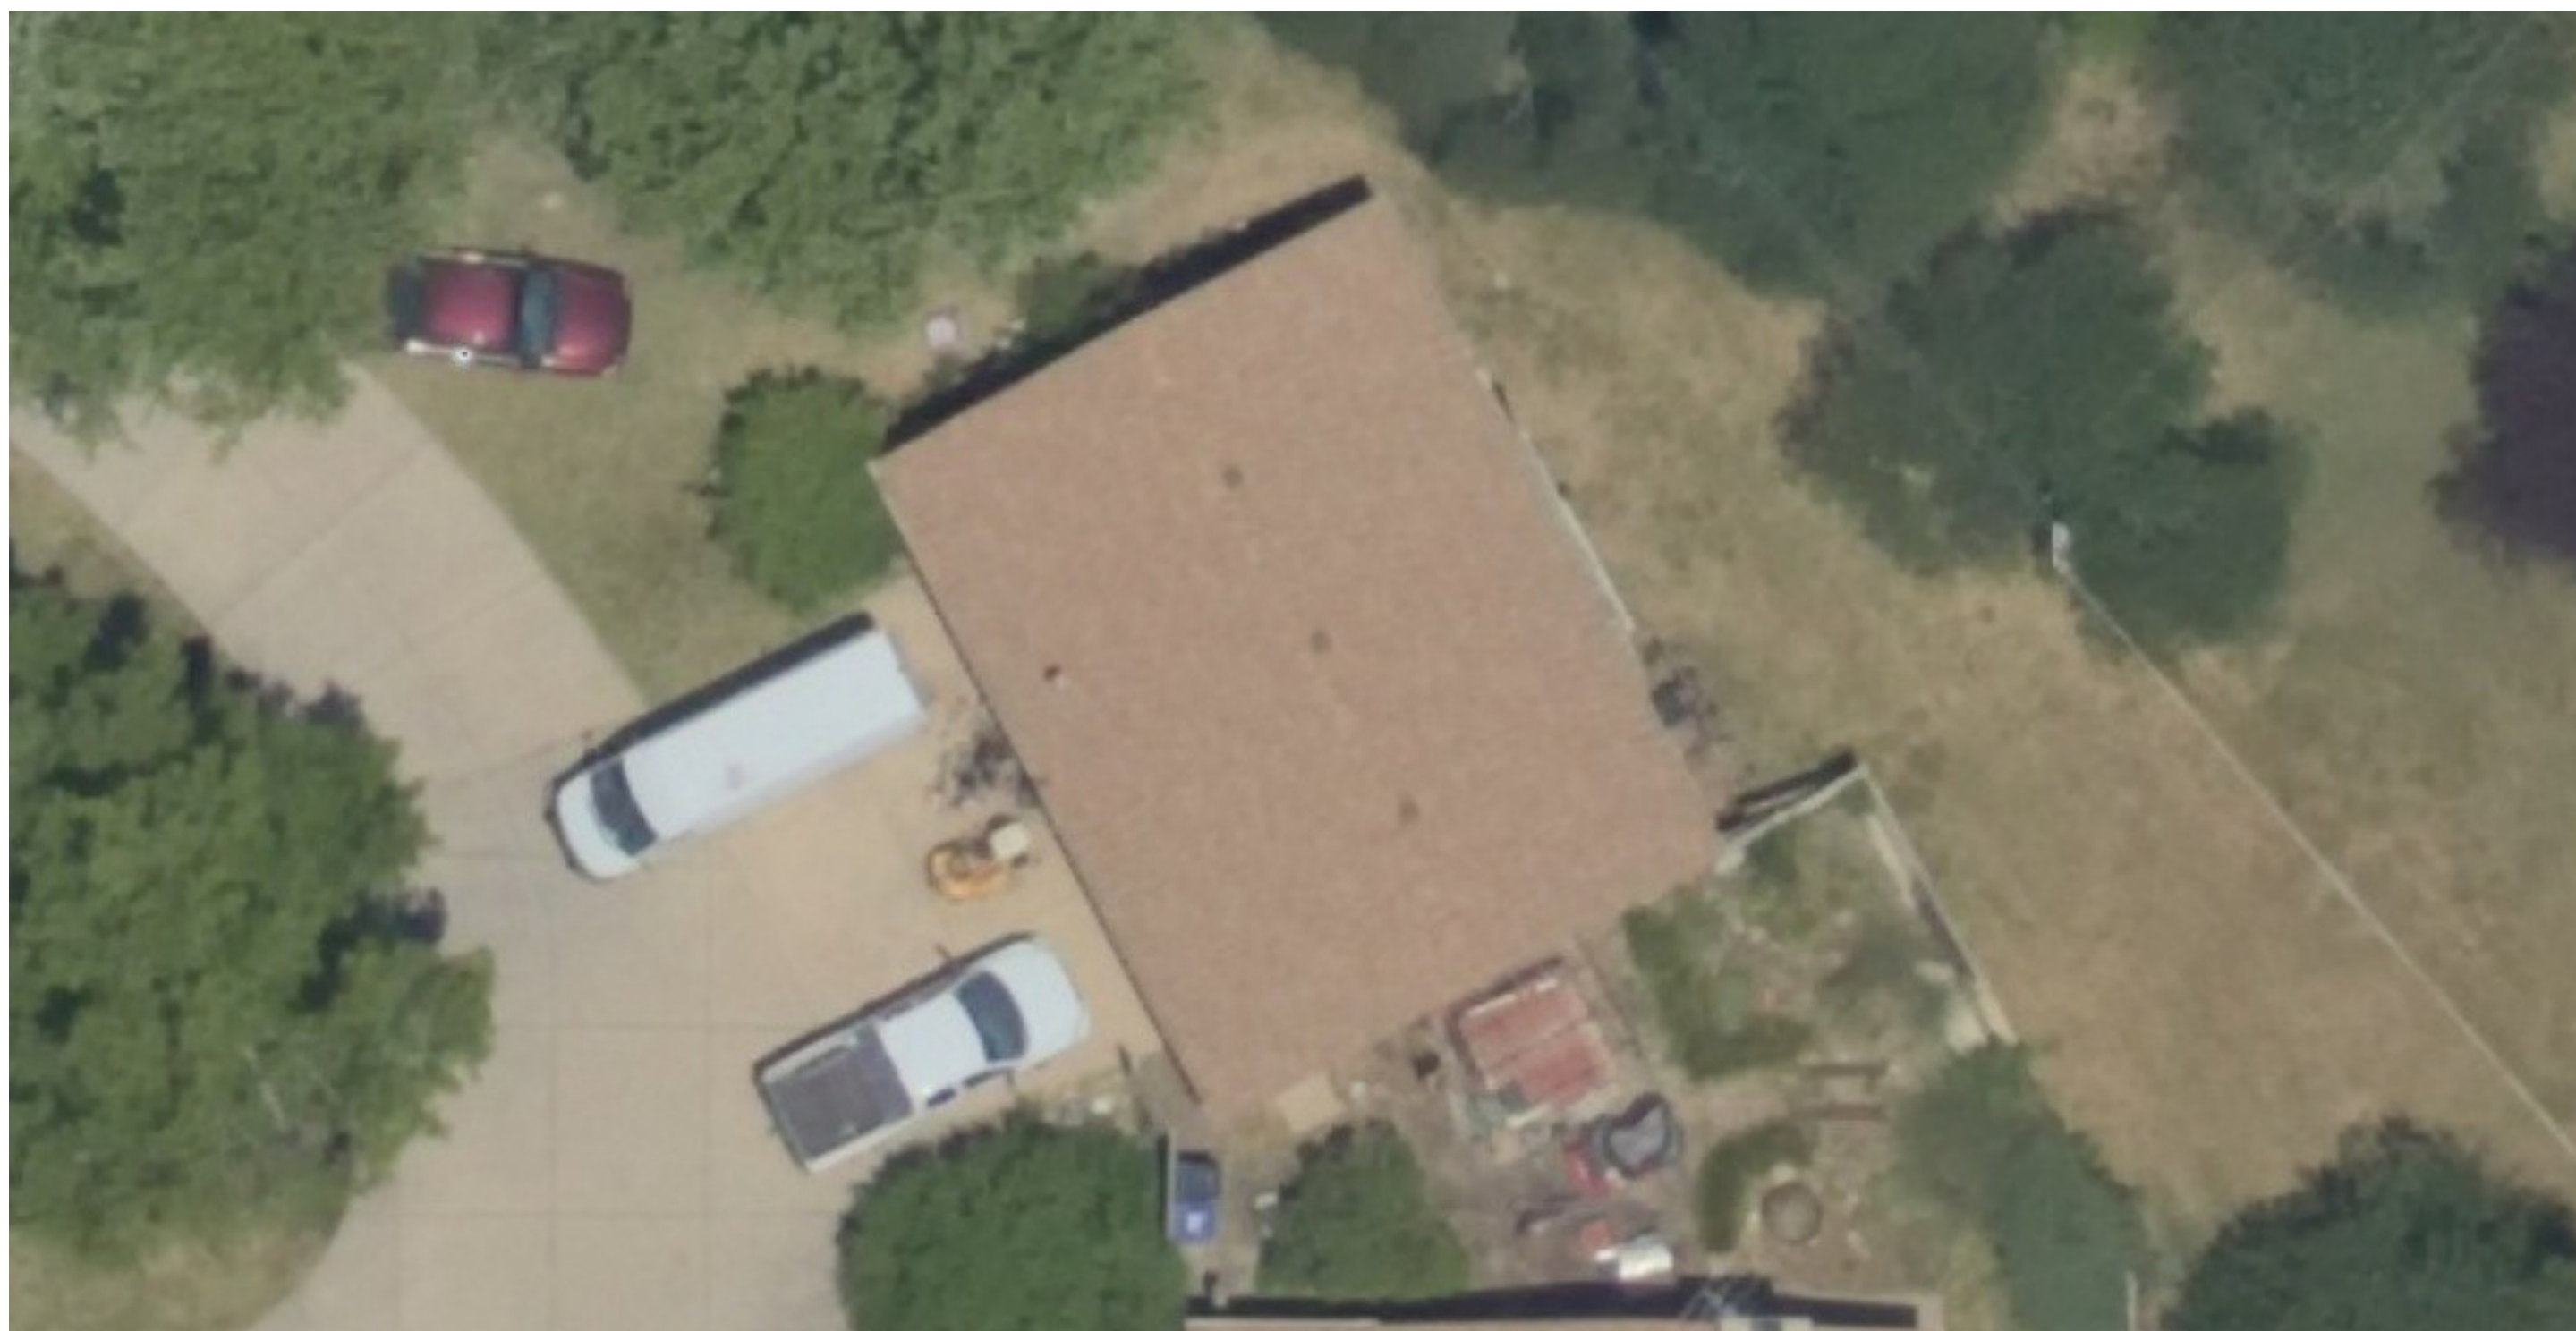
Pre-Damage Additional Building and Roof Attributes

Ground elevation	397.76 m	Roof shape	gable
Footprint area	135.42 m ²	Roof material	shingle
Roof elevation	0 m	Roof condition	5.00/5
Roof height	0 m	Roof discoloration	0%
Roof centroid	-97.134896 37.668001	Missing roof material	0%
Tree cover over roof	0%	Roof tarp	0%
Roof solar	NO SOLAR PANEL
