ELEMENTS PROPERTY REPORT

5915 Highland Hills Circle Fort Collins, CO, 80528, US

Vexcel Group

Report date: 05 February 2024

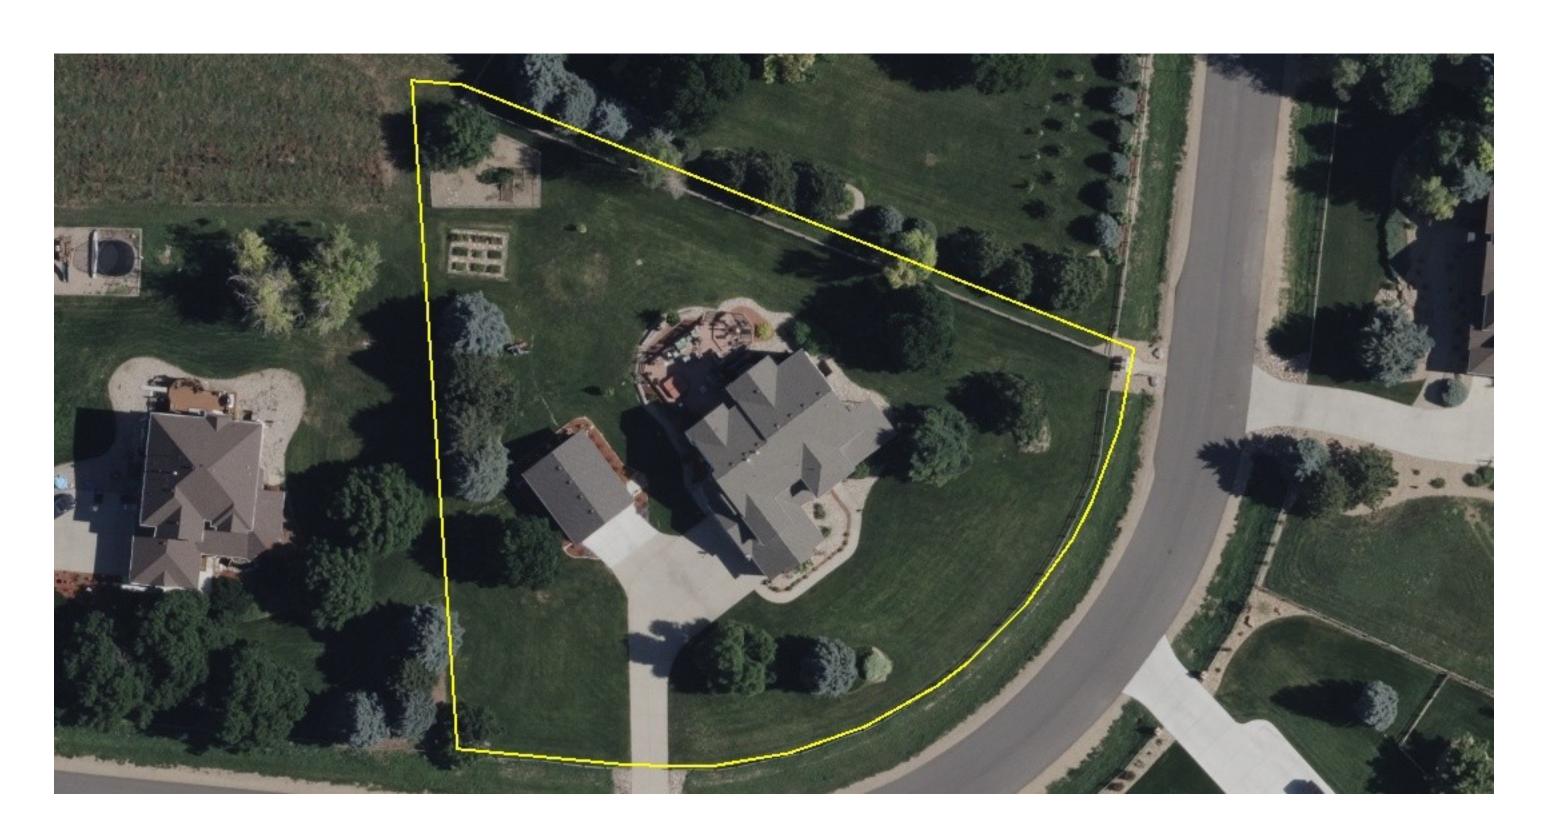
Property Attributes

Pool	No	Hardscapes - Area	333 m²
Pool: In Ground Area	N/A	Hardscapes – Parcel area %	8%
Pool: Above Ground Area	N/A	Playground	No
Hot Tub - Area	N/A	Trampoline	No
Enclosure	No	Sports court	No
Diving Board	No	Vehicles: Automobile(s)	0
Water Slide	No	Vehicles: Boat(s)	0
Deck	Yes

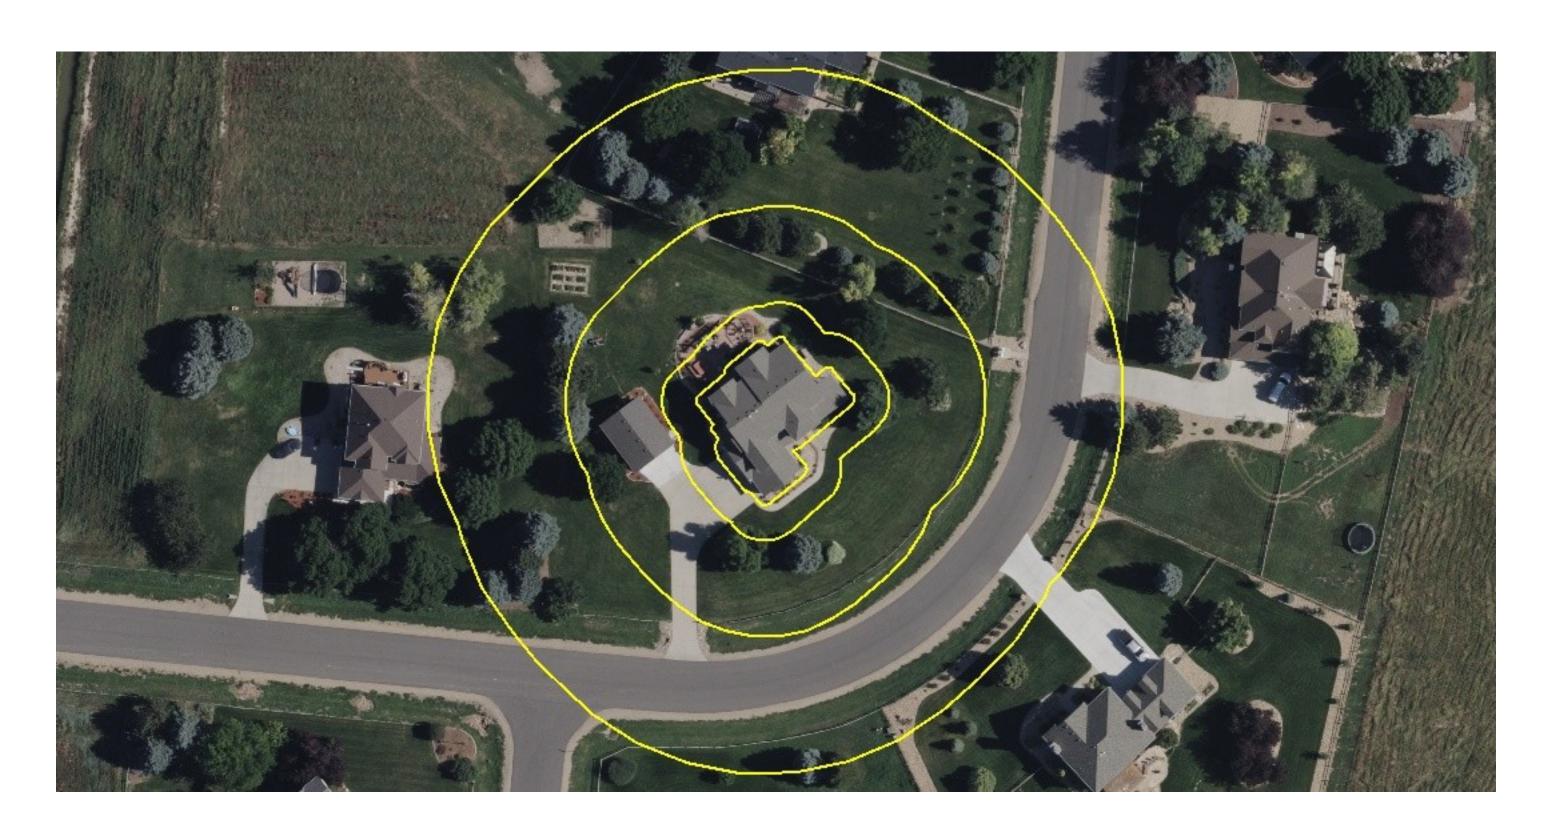
Primary Building: Defensible Space

DSB 5 ft	0%	DST 5 ft	1%
DSB 30 ft	0%	DST 30 ft	12%
DSB 100 ft	2%	DST 100 ft	15%
DSB 200 ft	4%	DST 200 ft	14%

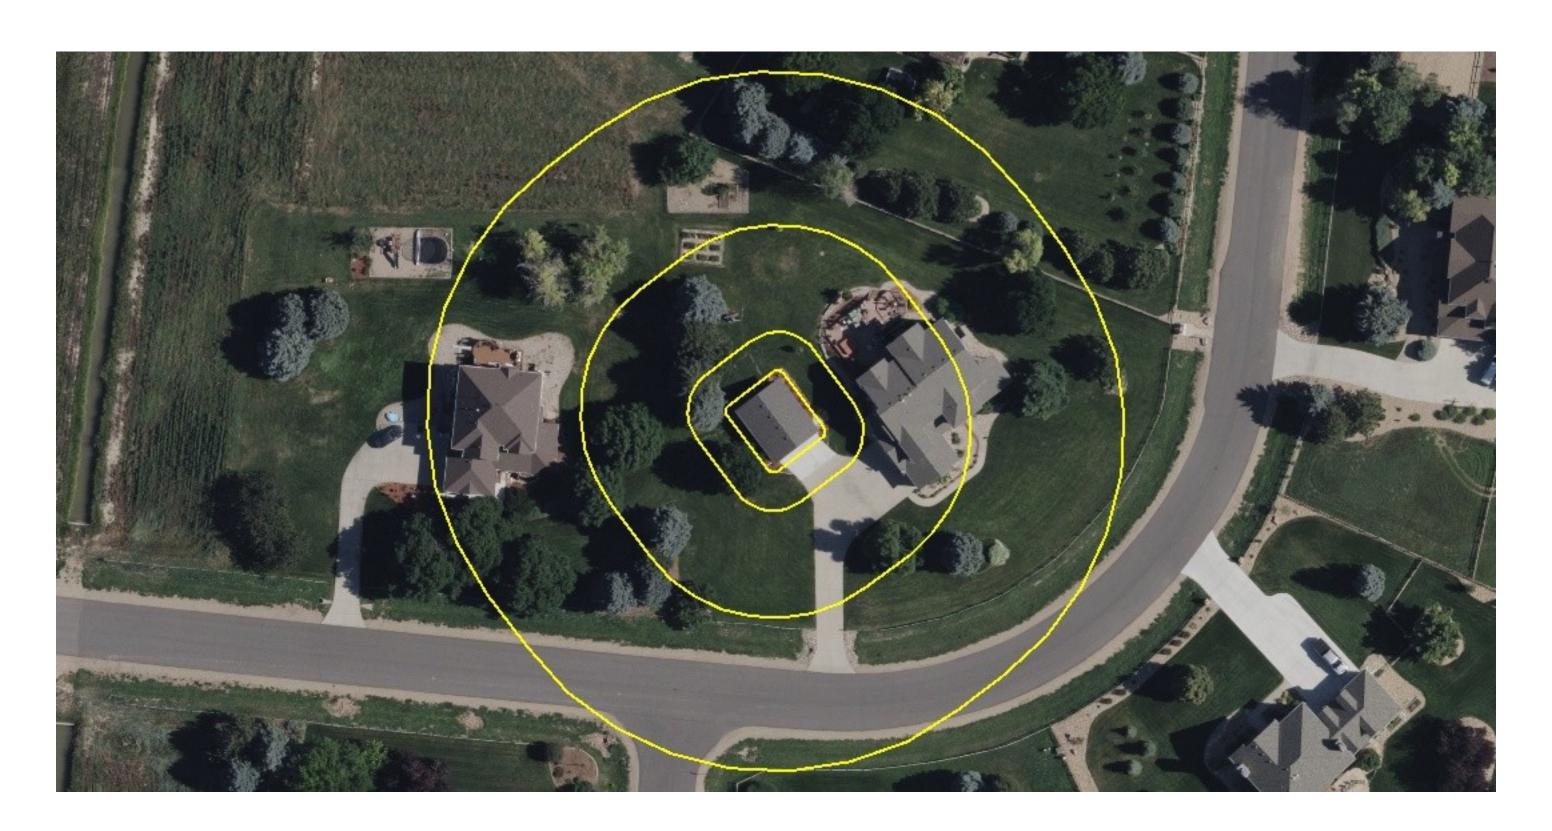
Additional Building: Defensible Space

DSB 5 ft	0%	DST 5 ft	6%
DSB 30 ft	1%	DST 30 ft	23%
DSB 100 ft	8%	DST 100 ft	17%
DSB 200 ft	5%	DST 200 ft	15%
